COMMONWEALTH ROOFING & SIDING, LLC. ROOF INSPECTION REPORT

Property Location: 1234 Main Street, Lancaster VA 22503

INSPECTION SUMMARY

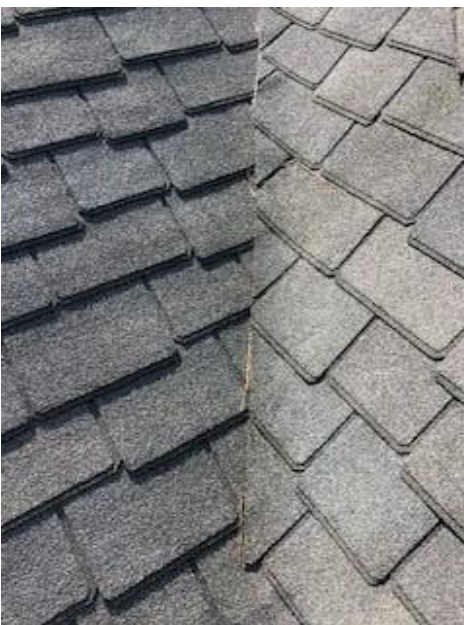
1 layer 2-ply Lifetime Architectural Shingle (GAF Woodland)

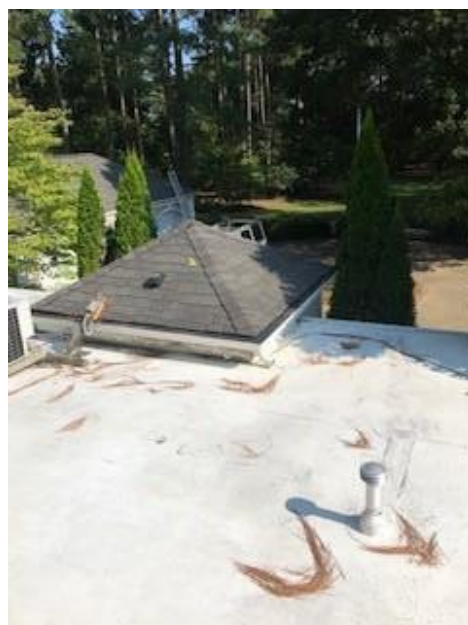
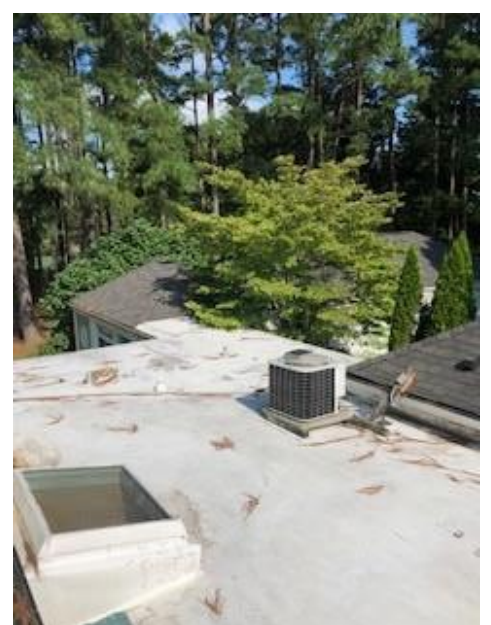
TPO flat roof system

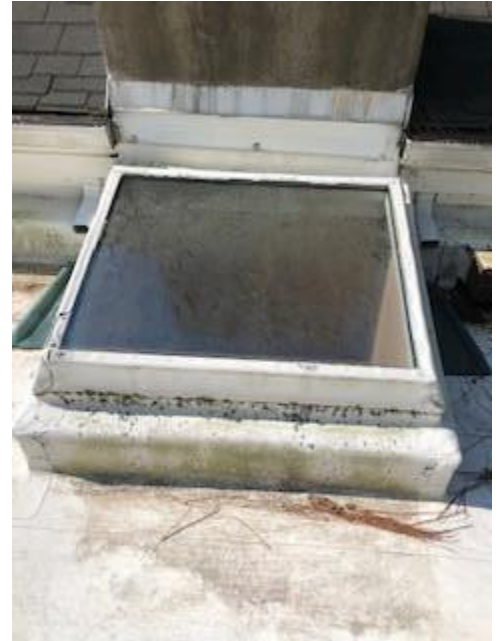
Skylight can be re-flashed however it is recommended it be replaced so the seal is not compromised from repairs.

Commonwealth Roofing & Siding, LLC. estimates the cost of repairs for replacing the skylight to be \$1,700.00. To re-build the support for the HVAC will be \$150.00. To install the missing trim wrap \$75.00. There will be no charge to trim the trees back from off the roof areas. Roof tune-up to shingle roof will be \$550.00. The coating of the flat roofing should be done but is not required and the estimated cost for repairs is \$6,500.00 (22 mil. thick silicone base coating for TPO). To opt to do a tune-up to the flat roofing instead of a coating the cost will be \$550.00.

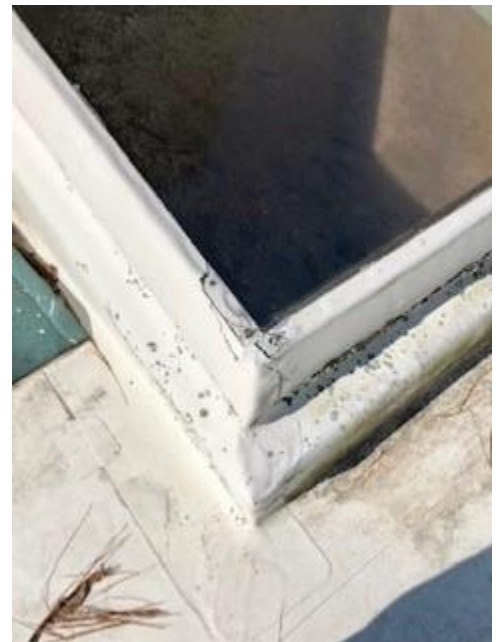
Corner of skylight appears to have squirrel damage which could compromise the effectiveness of the flashing at a minimum it should be re-flashed but a replacement is recommended to guarantee the seal.

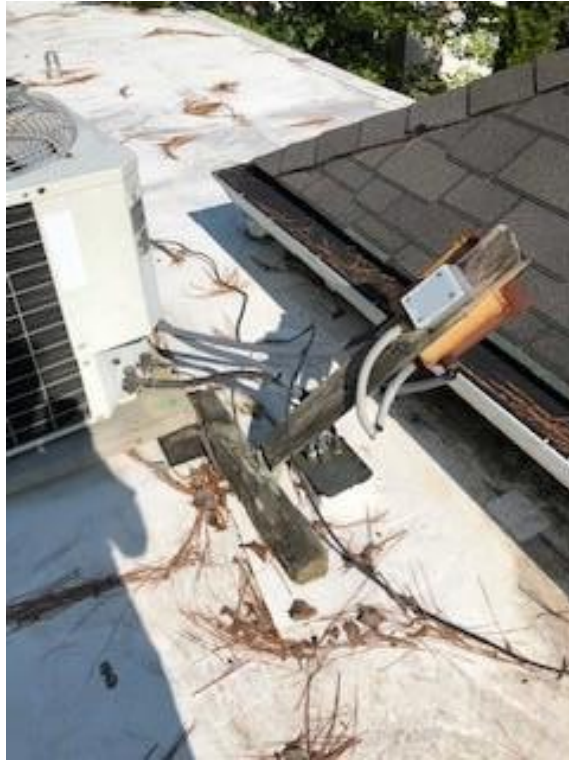
Support post for HVAC unit needs to be rebuilt and base needs to be re-flashed

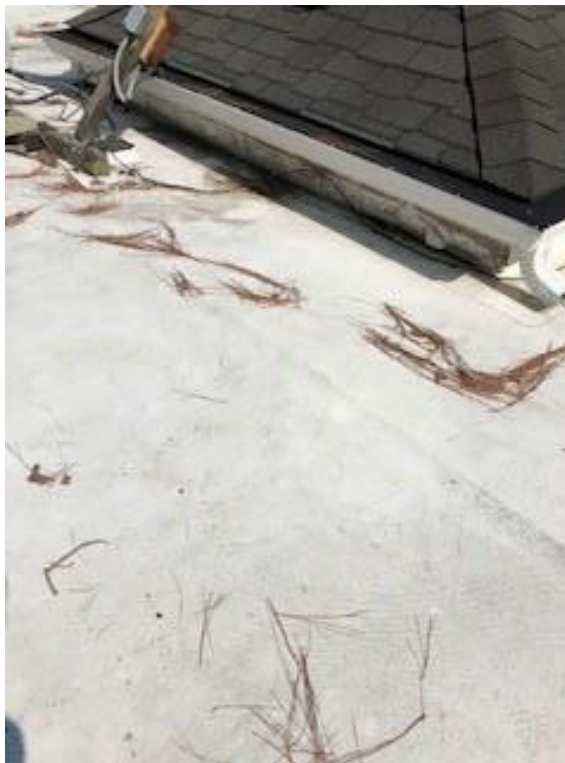
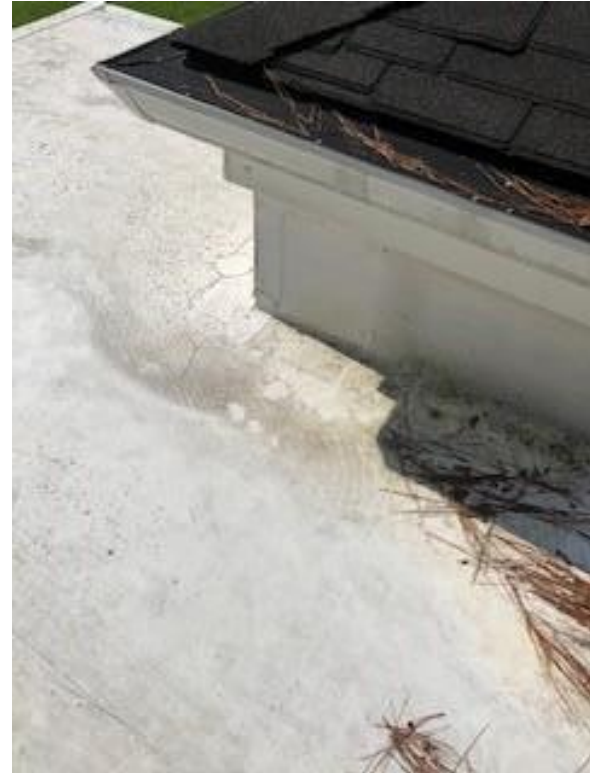
Trim wrap is missing from area to the right of the HVAC post and it is recommended a new piece of trim wrap be installed here

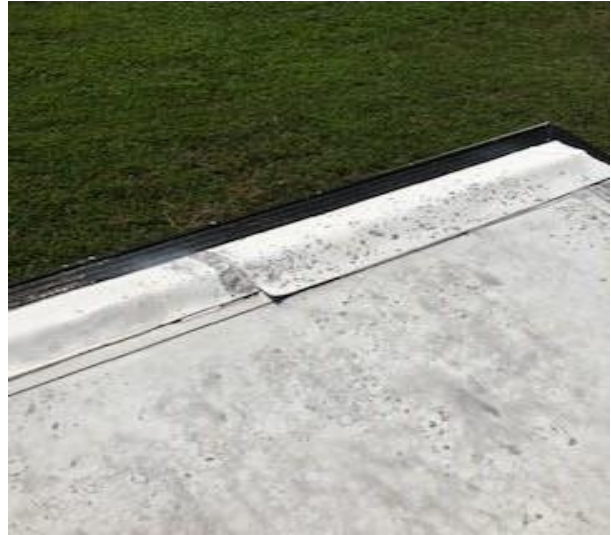
Corner of TPO flashing needs to be repaired

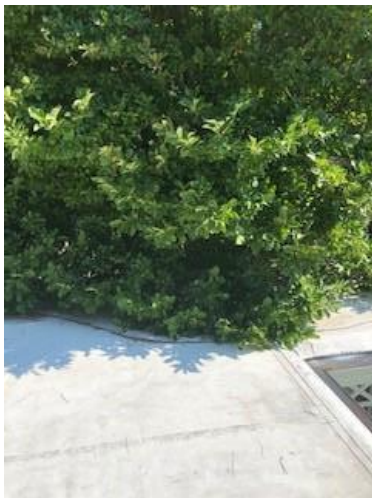
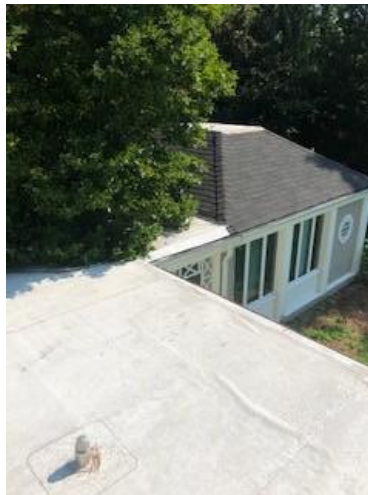
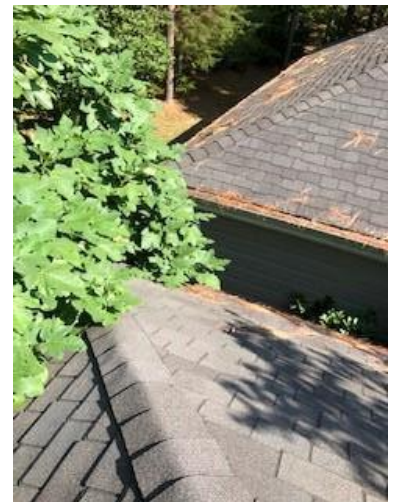
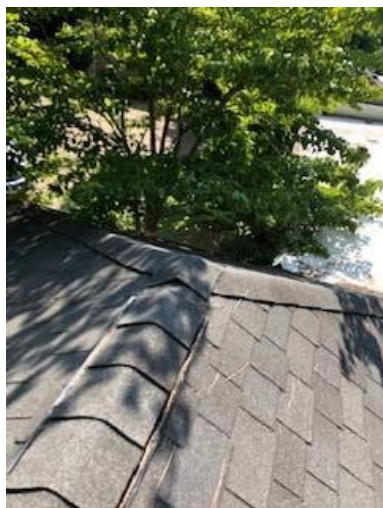
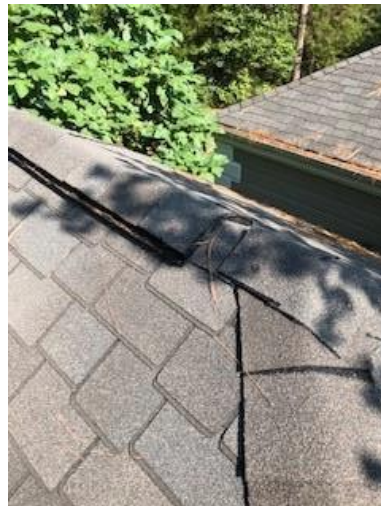
Portions of the roof have overhanging trees and it is recommended that these trees be cut back considerably as to not prevent any damage to the roofing systems. Multiple areas

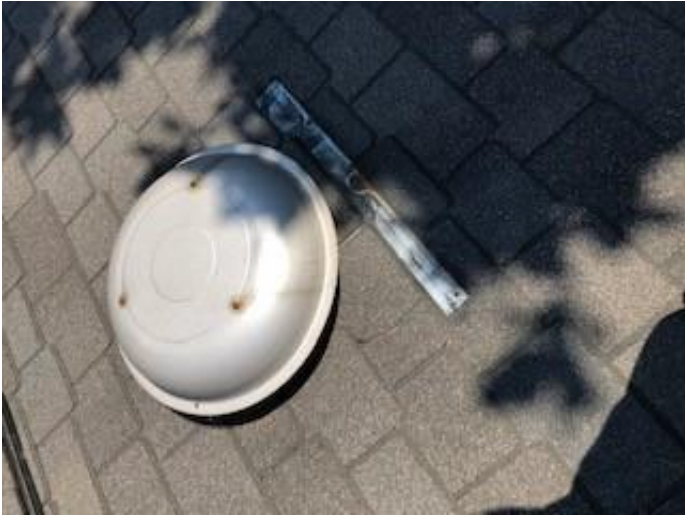
Power fan present,
need to re-secure
and caulk exposed
nail heads

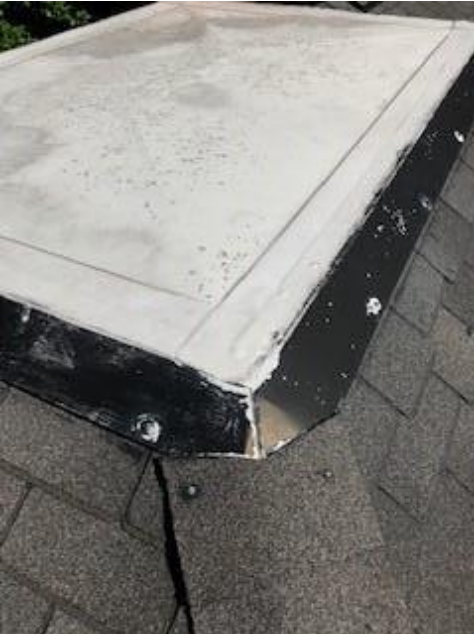
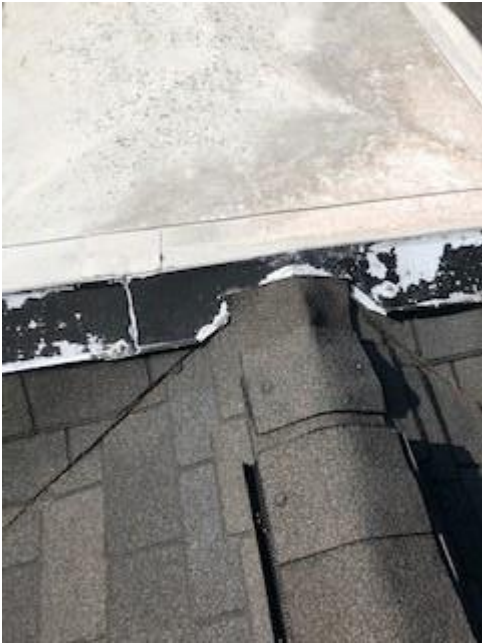
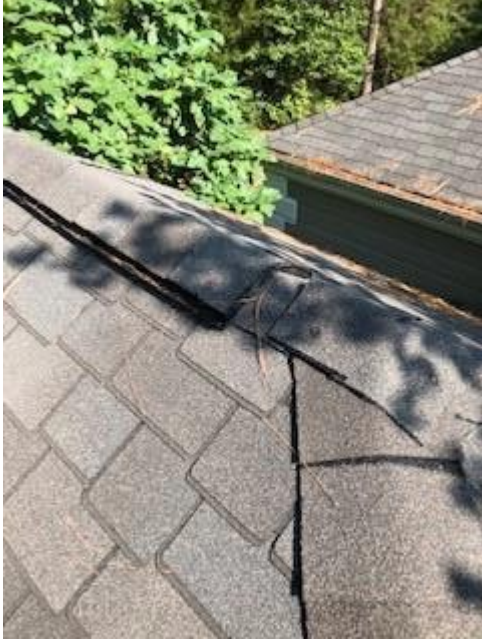
Nail heads on flashings and
Ridge vents need to be caulked

For the shingle portion the shingles are in good condition however with any roof that is at its half-life it needs a roof tune-up. We recommend that flashings on the roof be re-nailed and re-caulked and all exposed nail heads be re-caulked. No storm damage found during inspection. Recommend trimming the trees back until they no longer interfere with roof or gutter systems. The pitched portions of the roof have a ridge vent but are missing soffit intake vents which renders the ridge vent much less effective. It probably doesn't need it on the garage, but it would not be a bad idea on the other section to add a power attic fan for positive air flow (without doing attic and interior inspections it is hard to make sound ventilation recommendations). Flat roof is in good shape and was installed by someone who knew what they were doing. The skylight flashing has sustained damage likely from squirrels and will need to be re-flashed. The skylight itself may be the original and should also be replaced as it is now at the end of its useful life and would likely compromise the seal when re-flashing, so a replacement is recommended.
